ST. MARY'S HISTORIC DISTRICT

GUIDELINES STUDY

JUNE 30, 1986

GALYON AND ASSOCIATES / PDM
POST OFFICE BOX 1645
CHARLESTON, SOUTH CAROLINA 29402

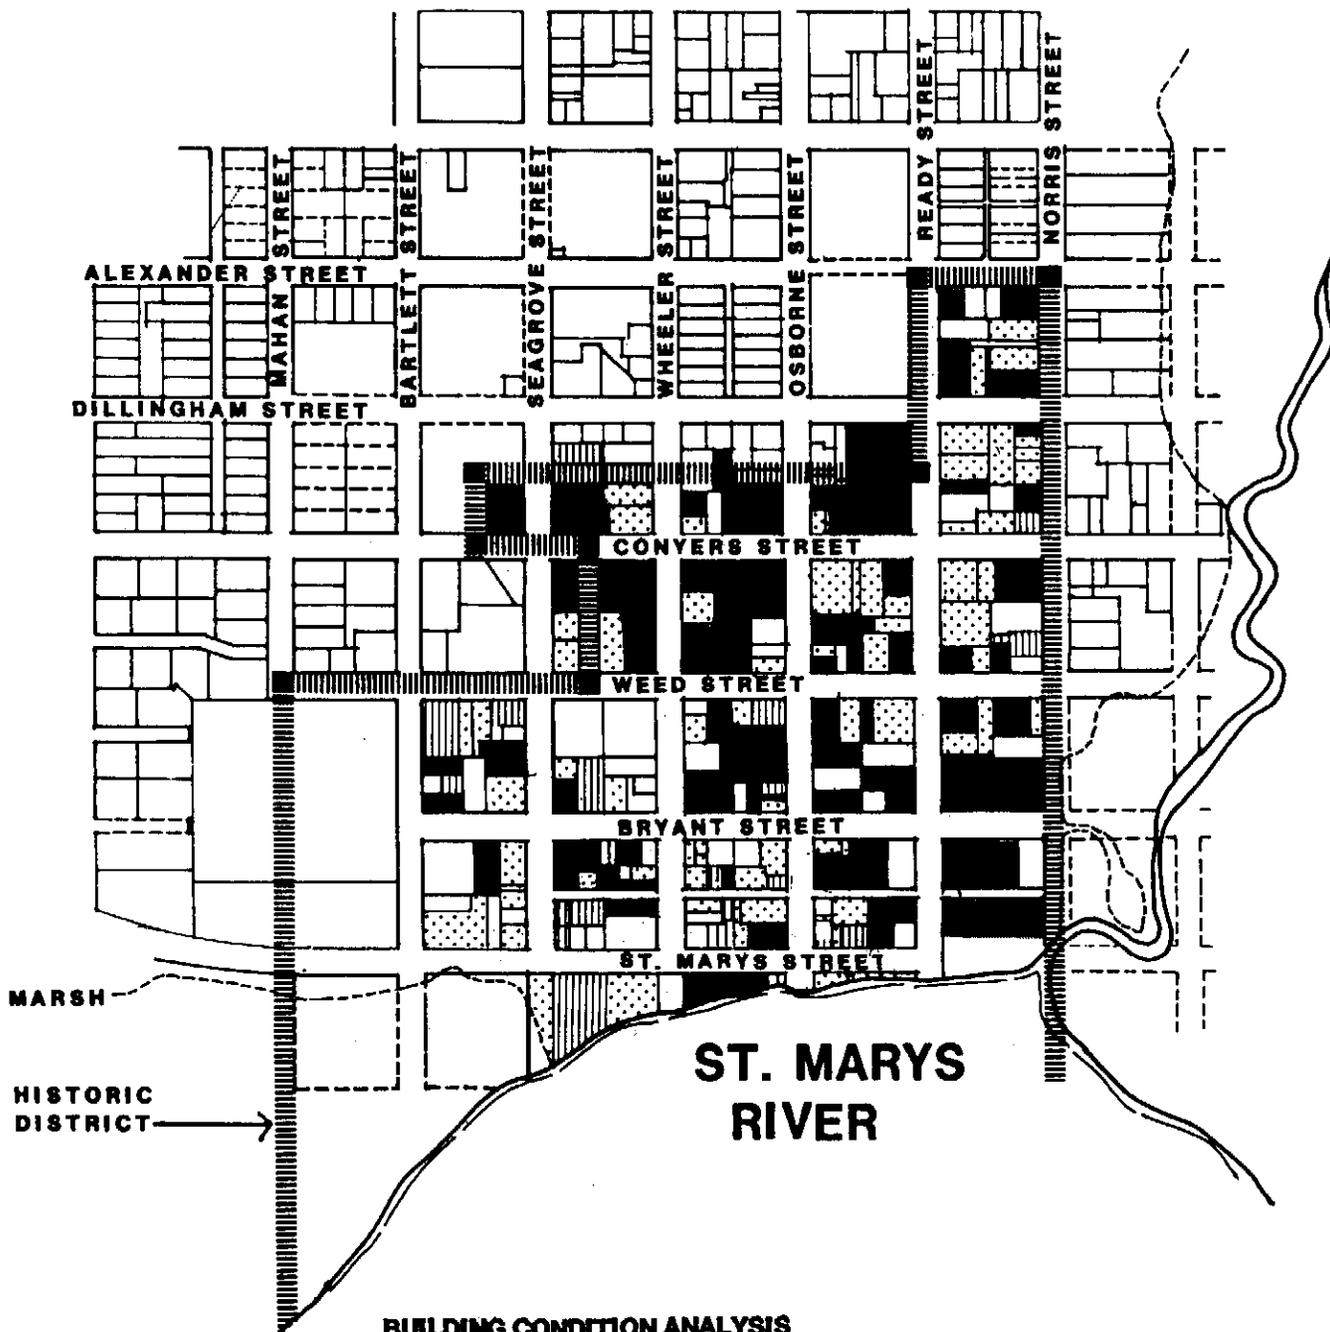
BUILDING CONDITION ANALYSIS

The buildings of the historic district were surveyed and their structural conditions were noted as of March, 1986. Information on building conditions is useful since it provides an overall indication of the physical condition of the historic district as well as a method of pinpointing individual buildings that require attention. Structures in need of major work can also be targeted for rehabilitation so that no historic resources are lost through neglect.

The result of the building condition survey was that 49% of the buildings in the historic district are in good condition. Another 63 structures, 39%, are in need of cosmetic attention. Cosmetic work includes cleaning, painting, and minor repair estimated to cost under \$2,500 per building. Only 19 buildings or 12% of the total structures in the historic district require major rehabilitation work. Major work includes correcting serious structural problems or roofing problems which will ultimately contribute to structural problems. Major repair work could cost as little as \$5,000.00 or could exceed the current value of the building. With the exception of only one or two structures rehabilitation appears to be preferable over demolition.

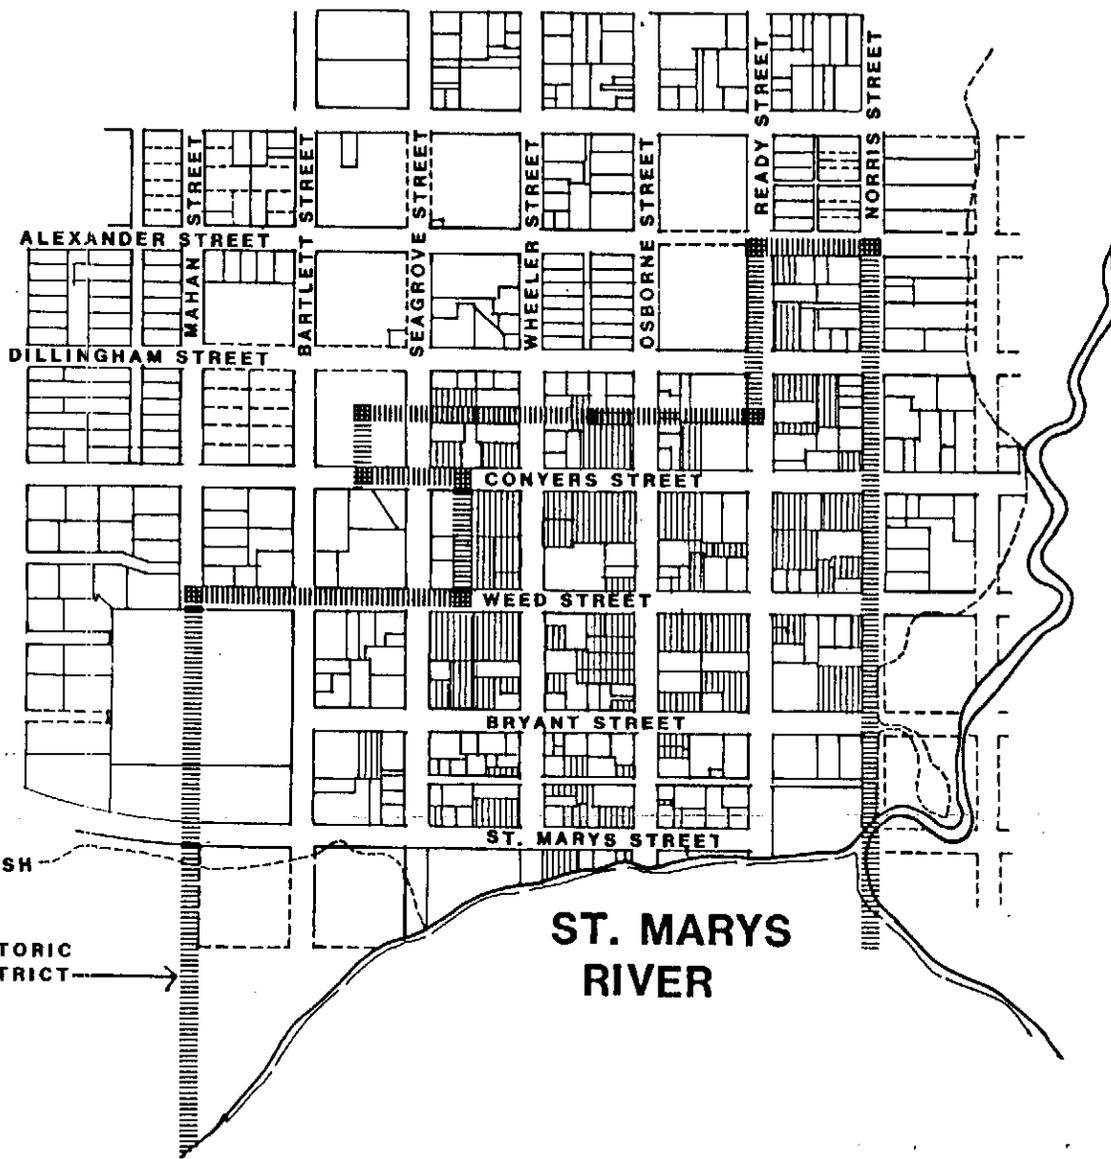
HISTORICAL STRUCTURE ANALYSIS

The St. Mary's Historic District was found to contain 59 buildings that contribute to the historic district. Contributory structures are identified as being a minimum of fifty years old and not seriously obscured by alteration. In the district some

37% of the buildings contribute historically. While few intrusive or detrimental structures were noted, the large percentage of non-contributory buildings indicates a need to redefine the historic district boundaries in order to concentrate design control on actual historic structures.

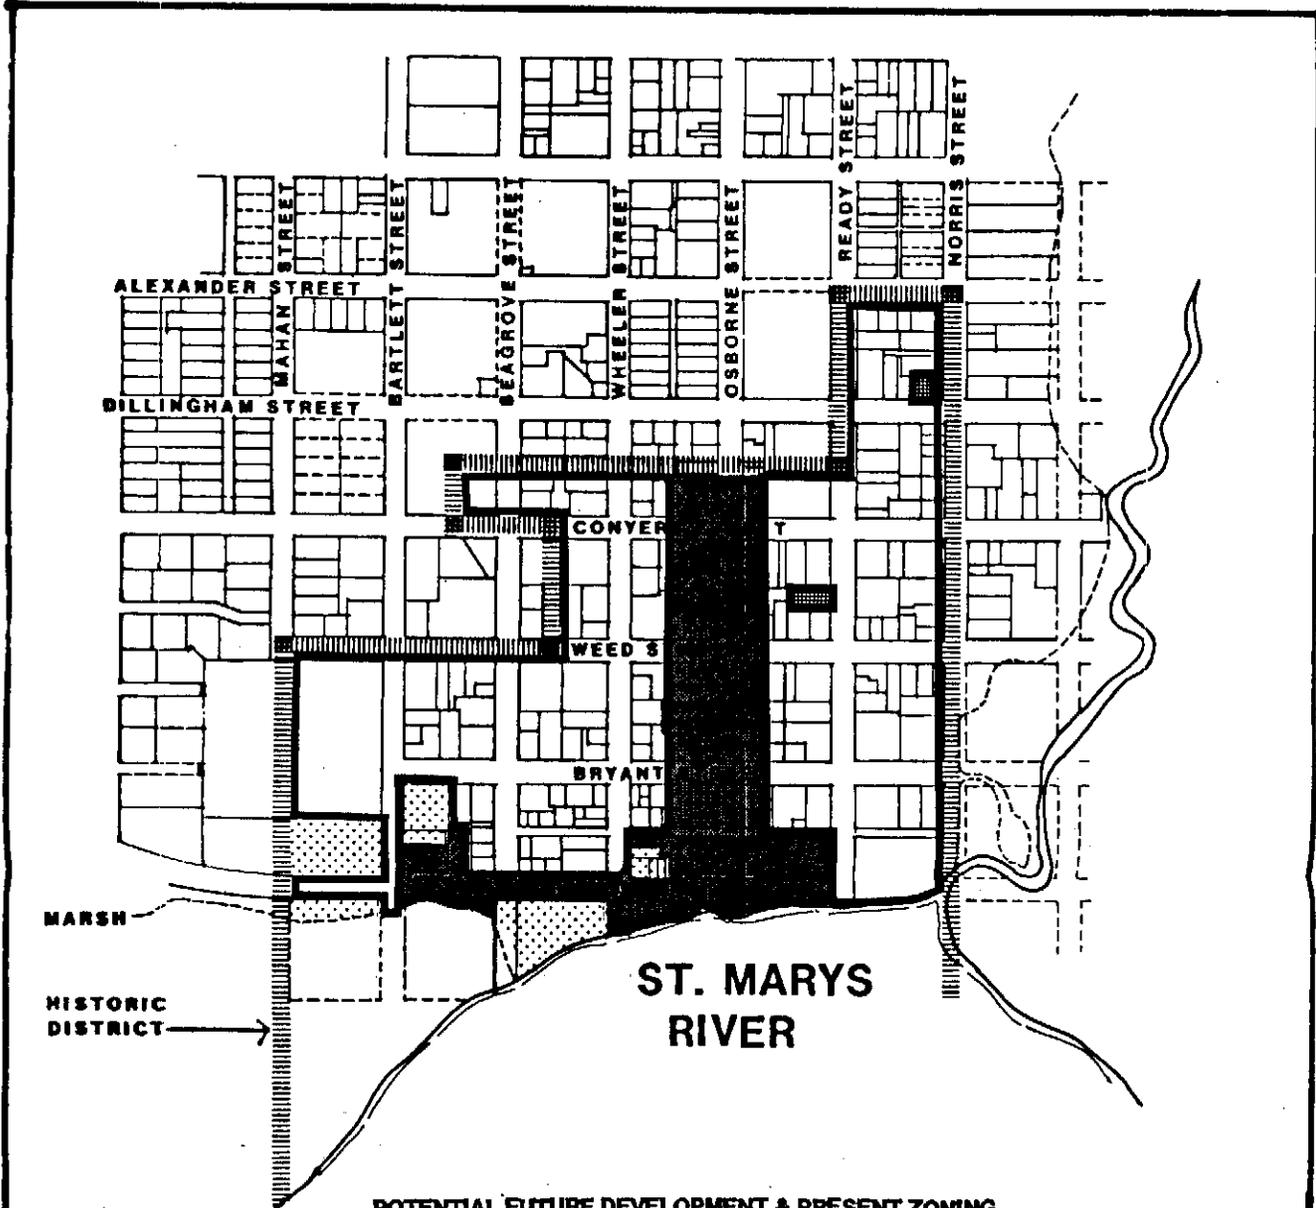
POTENTIAL FUTURE DEVELOPMENT & PRESENT ZONING

- ZONING DISTRICT O-1
 - FUTURE DEVELOPMENT
- ZONING DISTRICT R-3
 - ZONING DISTRICT R-1

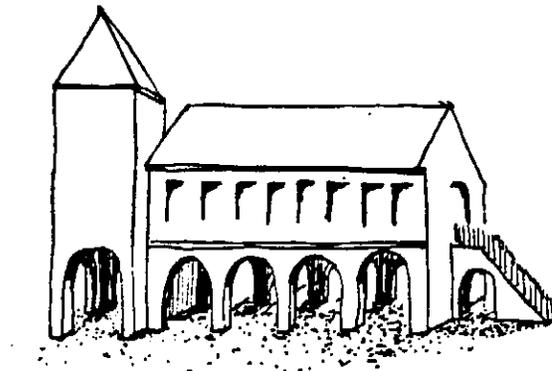
In many southern coastal communities it was not uncommon to see elevated structures on the water front providing an open-air area at ground level, and an enclosed commercial space above.

This design lends its self well to any new construction which might take place in the V-Zone. The open, ground level portion of the structure does not restrict the river views of the passerby, and in effect, creates an interesting picture of the water by framing the views and gradually arousing the curiosity of the viewer.

The space created at the ground level could be utilized as an open air market area providing festive retail space as well as an area of shade for those people waiting for the boat to Cumberland Island. This area could become an area of great activity.

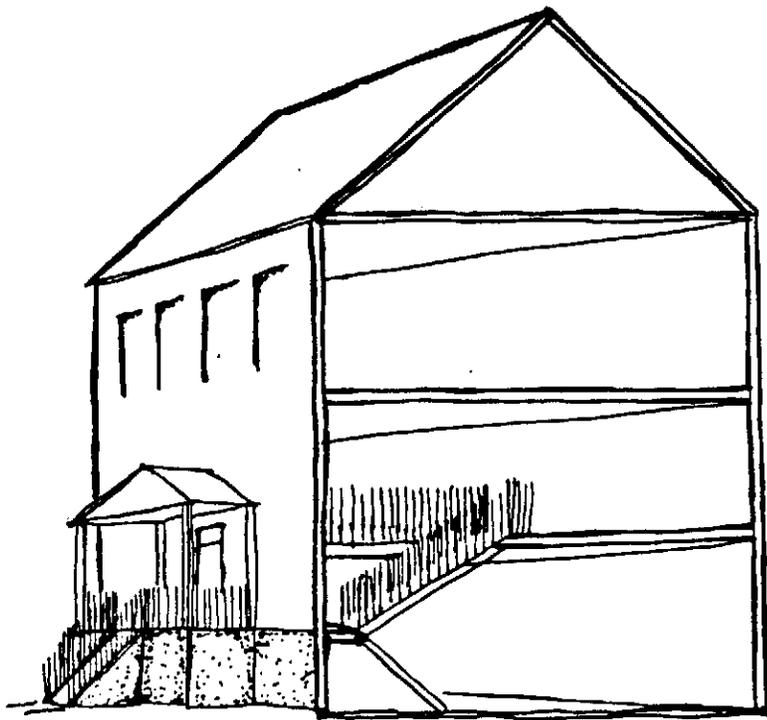
same conditions as the existing houses except that the finished first floor elevation must meet the flood one requirements. This means that the building must be elevated at least 4' - 7' above existing grade. If the structure adjoins existing historic structure, the elevation of the first floor or the exterior appearance must be in keeping with the elevation of the existing structures. The majority of the existing houses are elevated to some degree and this presents little or no problem except when the owner wishes to utilize the area under the building for parking or storage. In this instance one solution is to create the illusion of the first floor being lower through the design element of the porch. In this manner, the individual entering the structure appears to be entering at the first level, but in actuality enters into a foyer and once in proceeds up to the first floor.

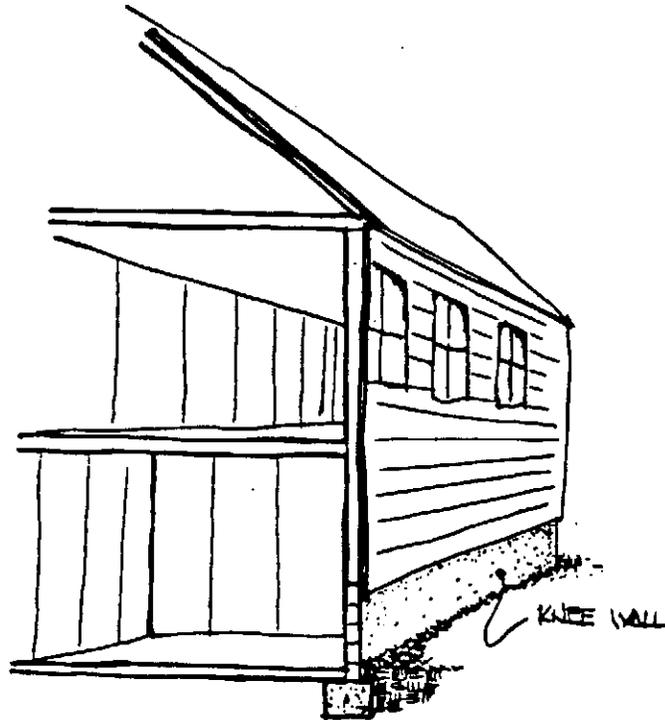
In other instances, where the porch element is not appropriate, the entrance itself, as well as the appearance of the foundation, can give the illusion of the first floor being lower. The skin of the building can be designed to create what appears to be the top of the foundation which is congruous with the adjoining structures through the use of a masonry knee wall.

Another solution would be to place the entrance of the building at the appropriate level relative to the adjoining structures and once in the structure proceed up by stairs.

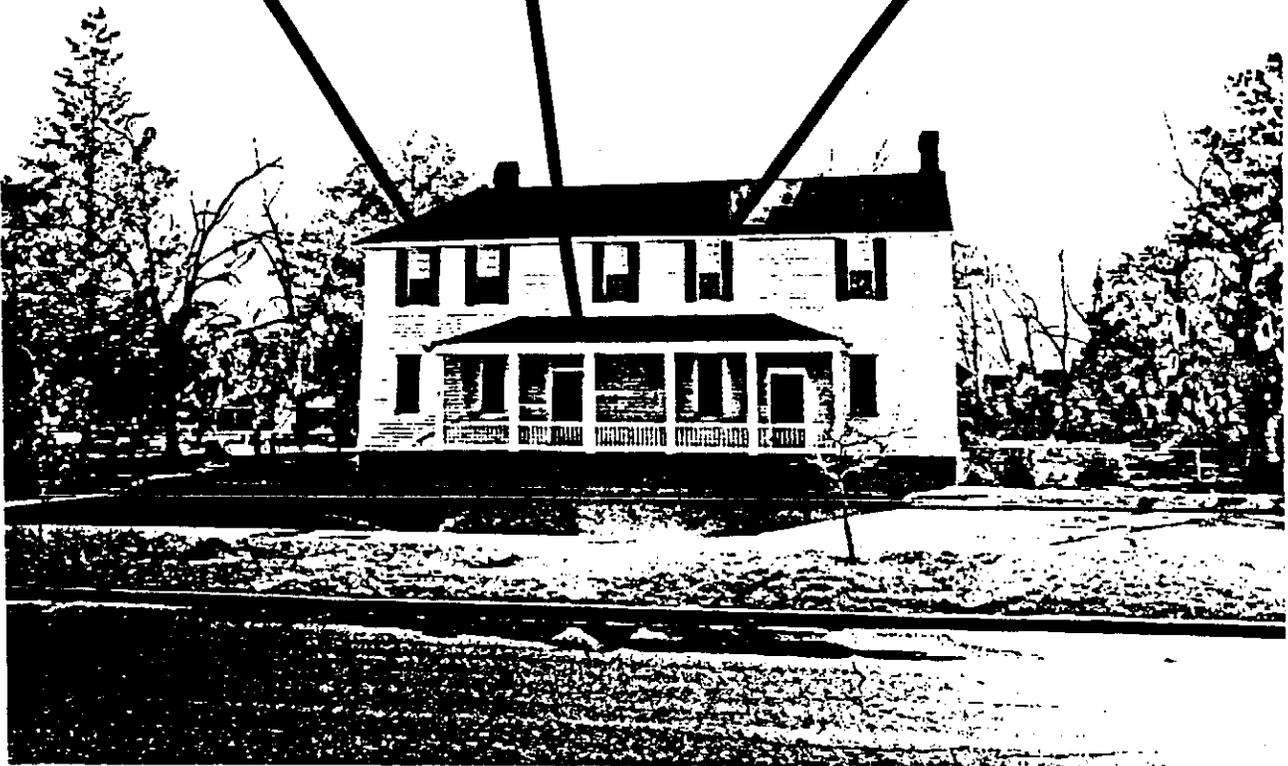
GEORGIAN c. 1801

9/9 WINDOWS

JACKSON-CLARK-BESSENT HOUSE

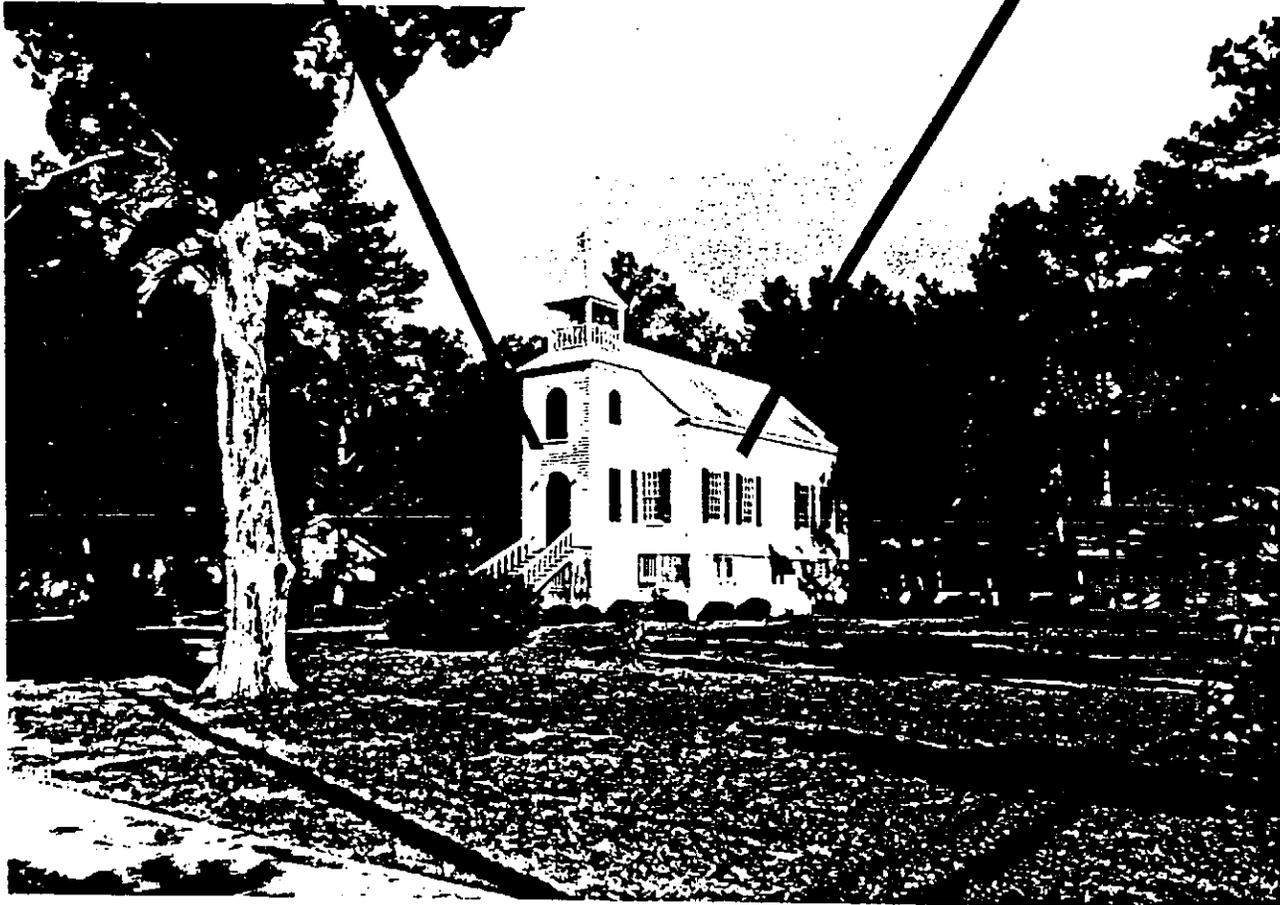
FEDERAL c. 1808

12/12 WINDOW PANES

PRESBYTERIAN CHURCH

Federal period buildings include such examples as the Presbyterian Church, c. 1808, and the Burns House, c. 1840's. The church building displays the very common Federal detail of the elliptical window and door treatment as well as twelve over twelve window panes. The Burns House is a good Federal style example with its hipped roof, five bay facade, elliptical fanlight over the entrance door and windows. The windows are nine over nine panes on the first floor and six over nine panes on the second floor.

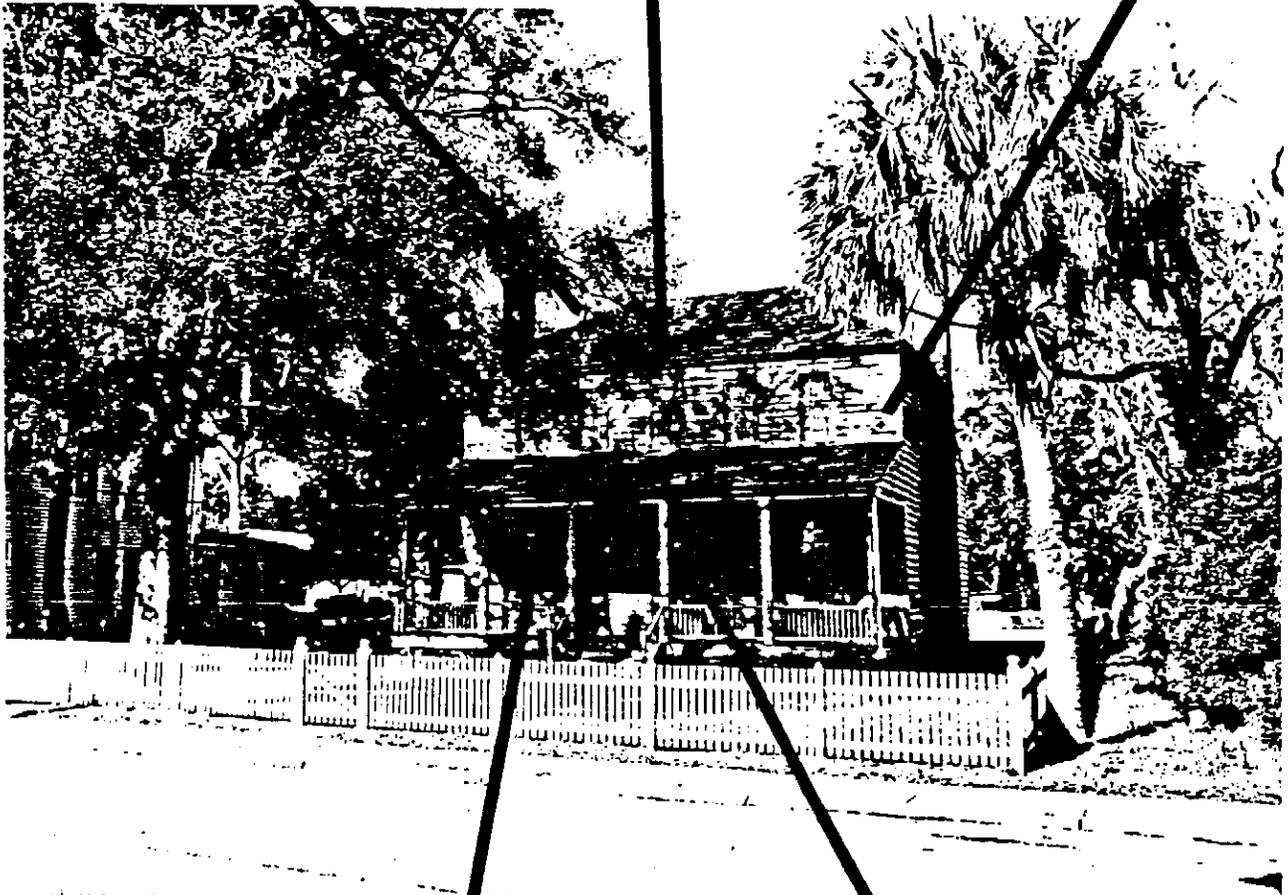
BURNS HOUSE

FIVE BAY FACADE

9/9 WINDOW PANES

FANLIGHT OVER DOOR

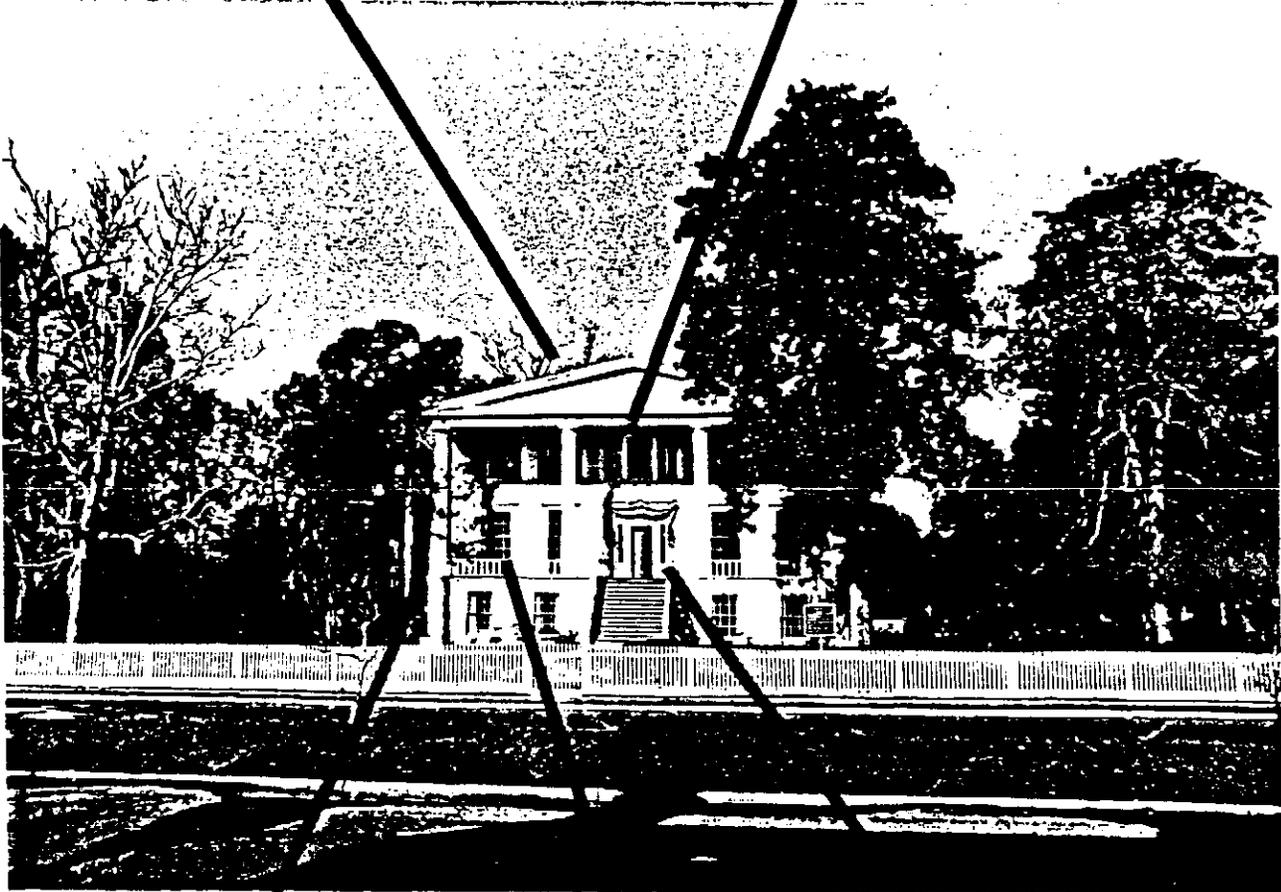
THREE PART WINDOW
FULL FACADE PORCH

FLUTED, DORIC COLUMNS

6/6 WINDOWS

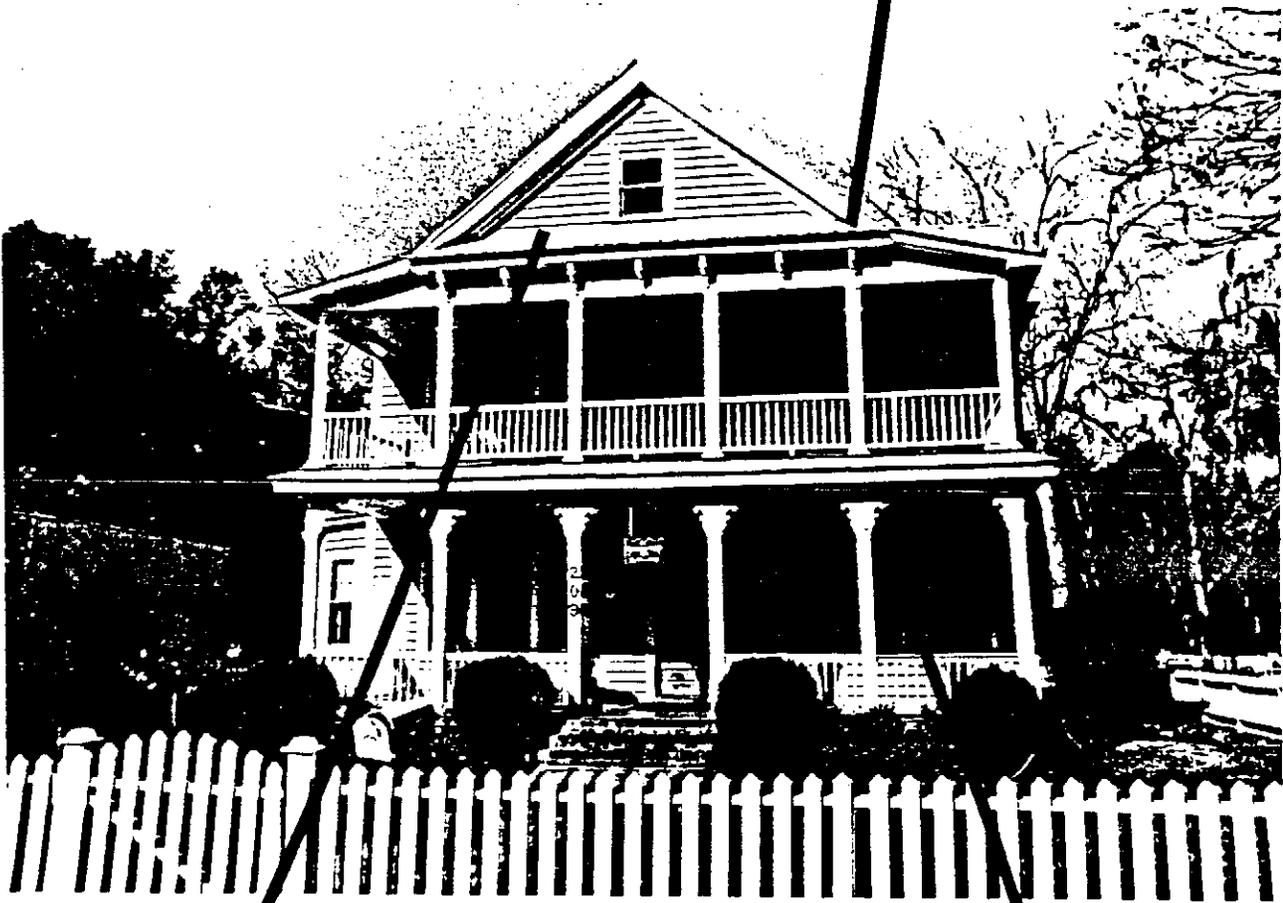
BRACKETS UNDER EAVES

SYMMETRICAL FACADE
SIDE GABLED ROOF

SCROLLED PORCH BRACKETS

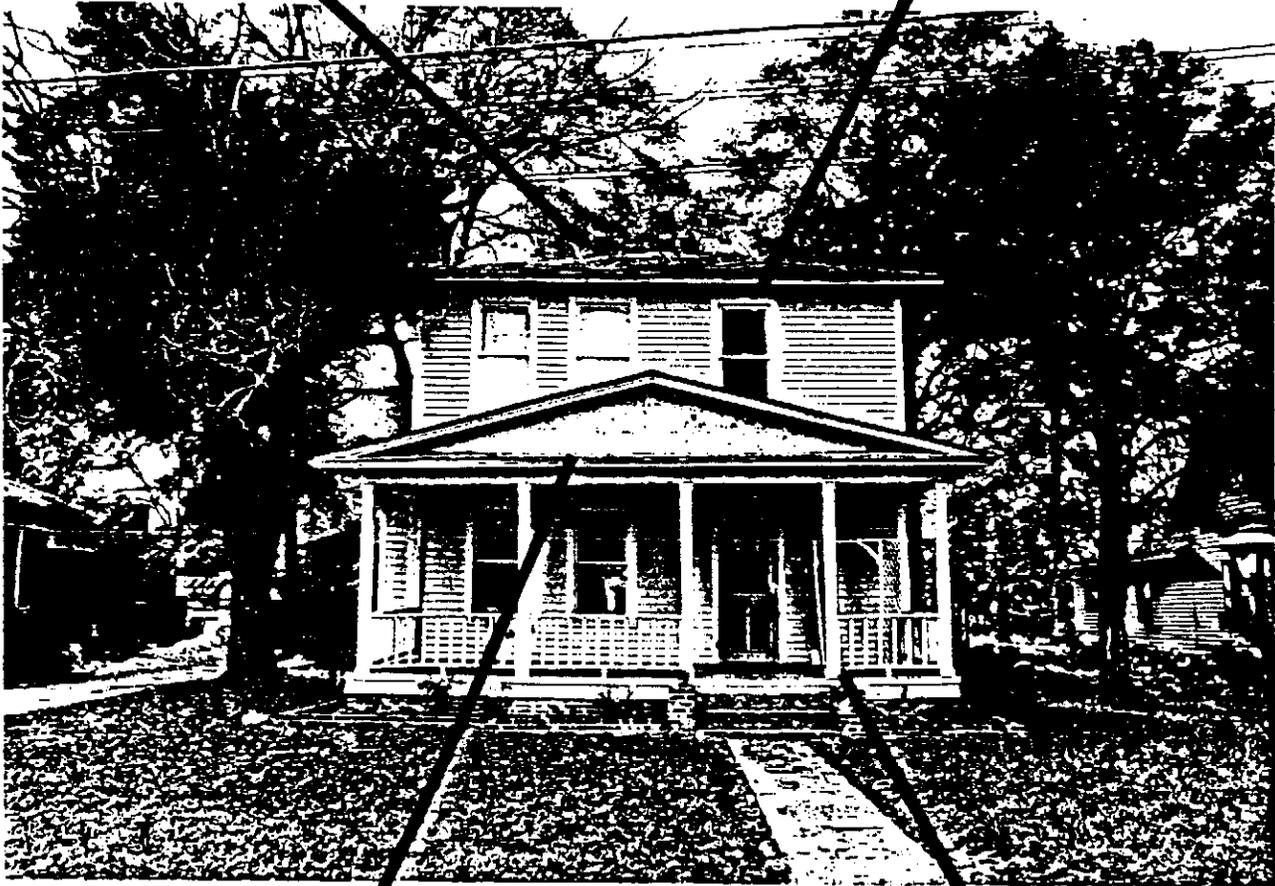
1/1 WINDOWS

PEDIMENTED, FULL WIDTH PORCH

CLASSICAL COLUMNS

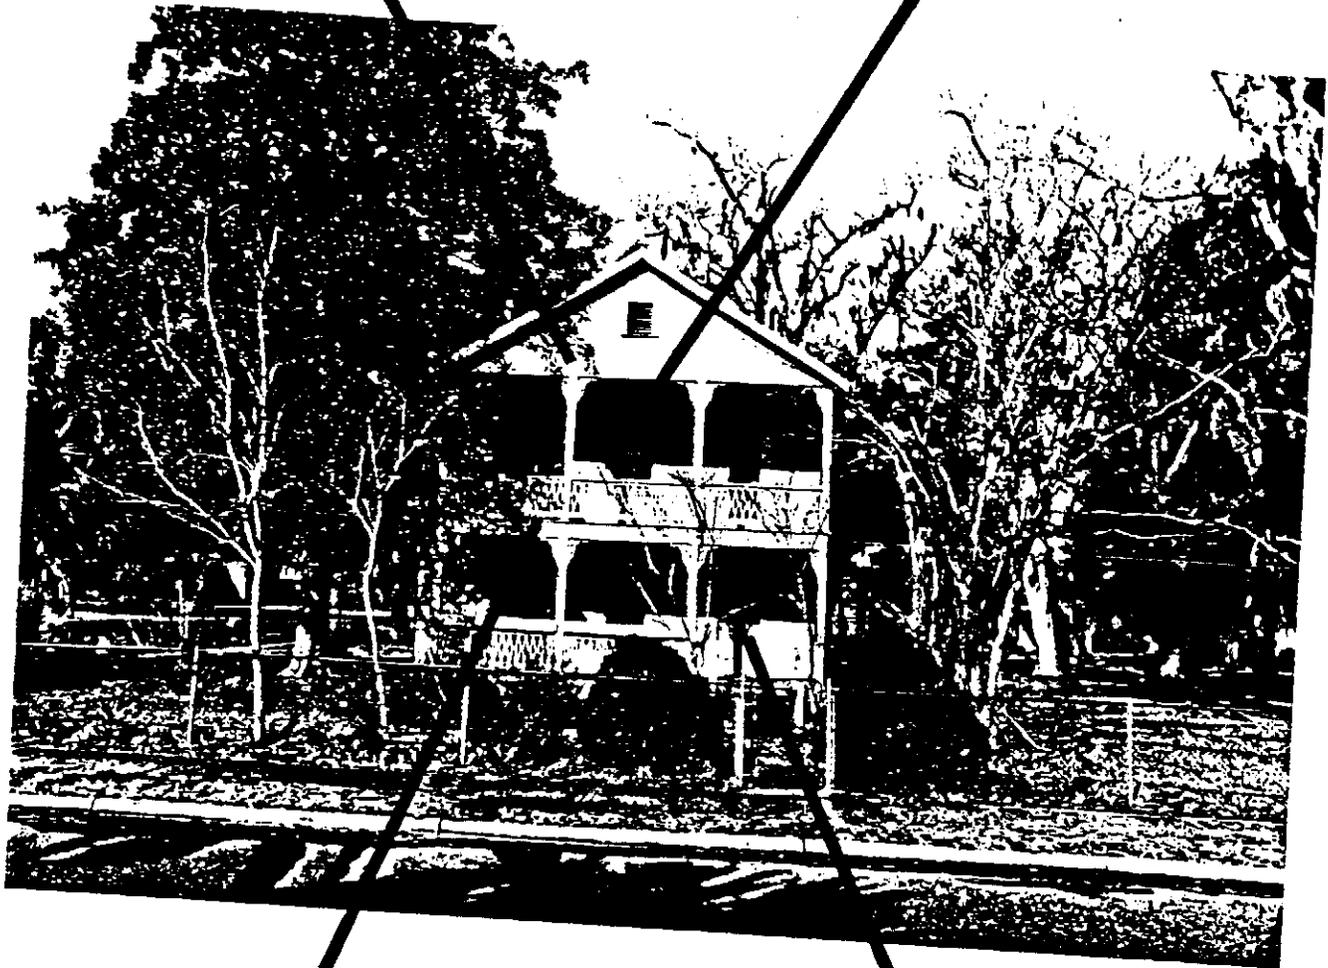
2/2 WINDOW PANES

LIGSAWN BALUSTRADES

FRONT GABLED ROOF
SIMPLE HOUSE FORM

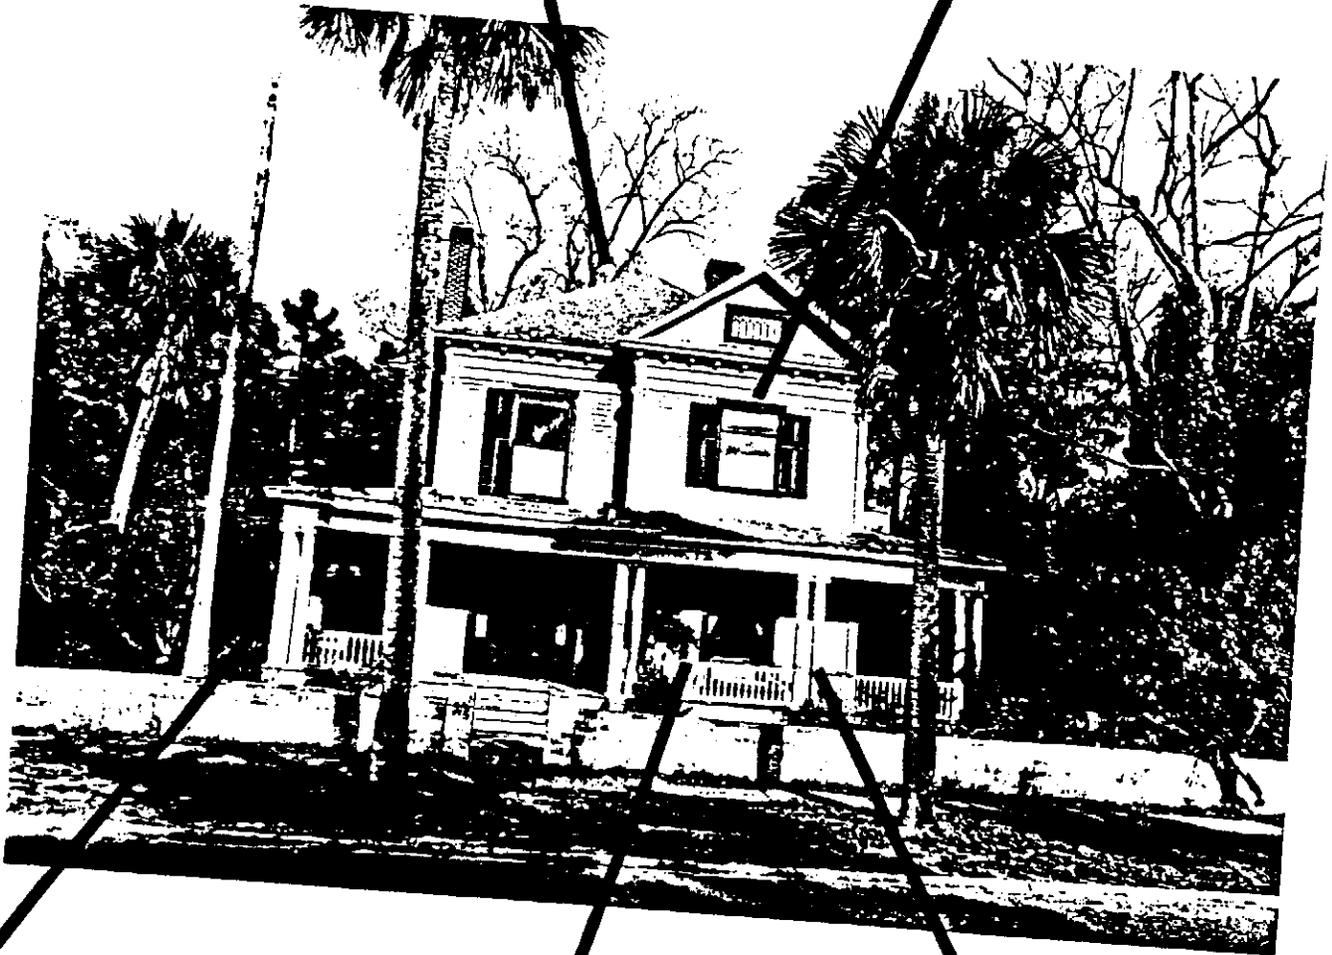
1/1 WINDOWS

FULL WIDTH ONE STORY PORCH

ASYMMETRICAL FACADE

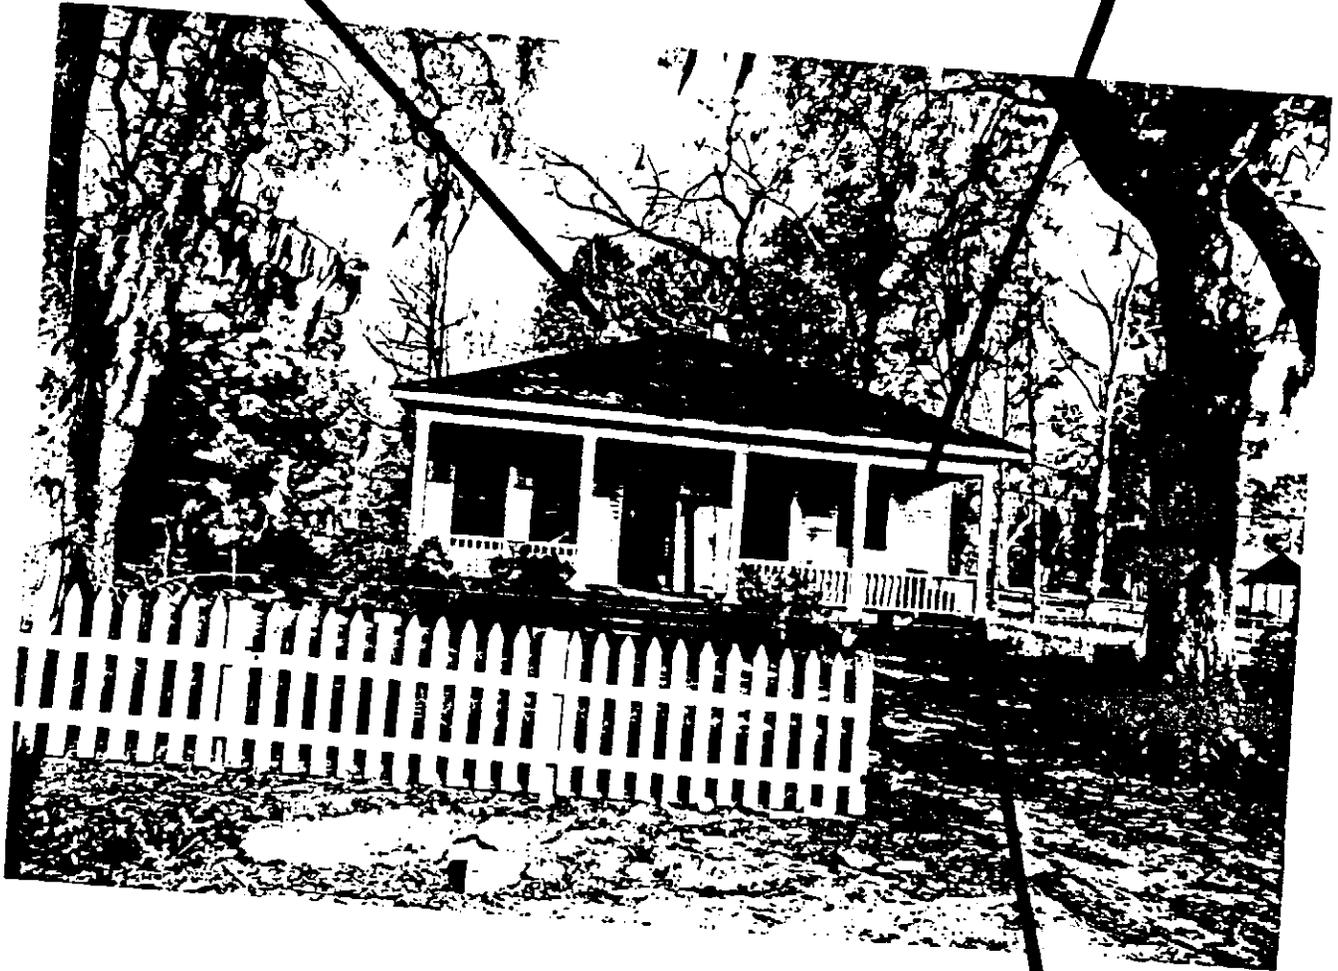
NEOCLASSICAL COTTAGE c. 1915

FULL WIDTH PORCH UNDER
MAIN ROOF

CLASSICAL COLUMNS

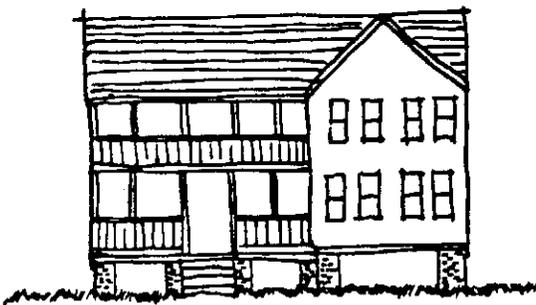
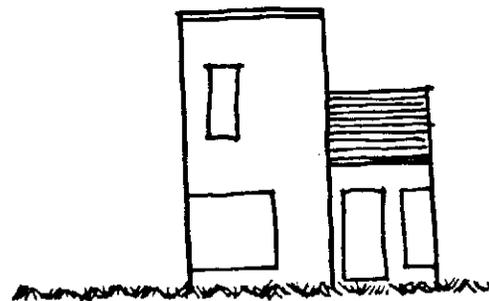
2. Floor elevation - When new construction is proposed for infill in the historic district, the first floor elevation and subsequent interior floor elevations should average that of adjacent buildings where ever possible. While there are problems associated with anticipated flood elevations, it is hoped that this conflict can be minimized.

THIS

NOT THIS

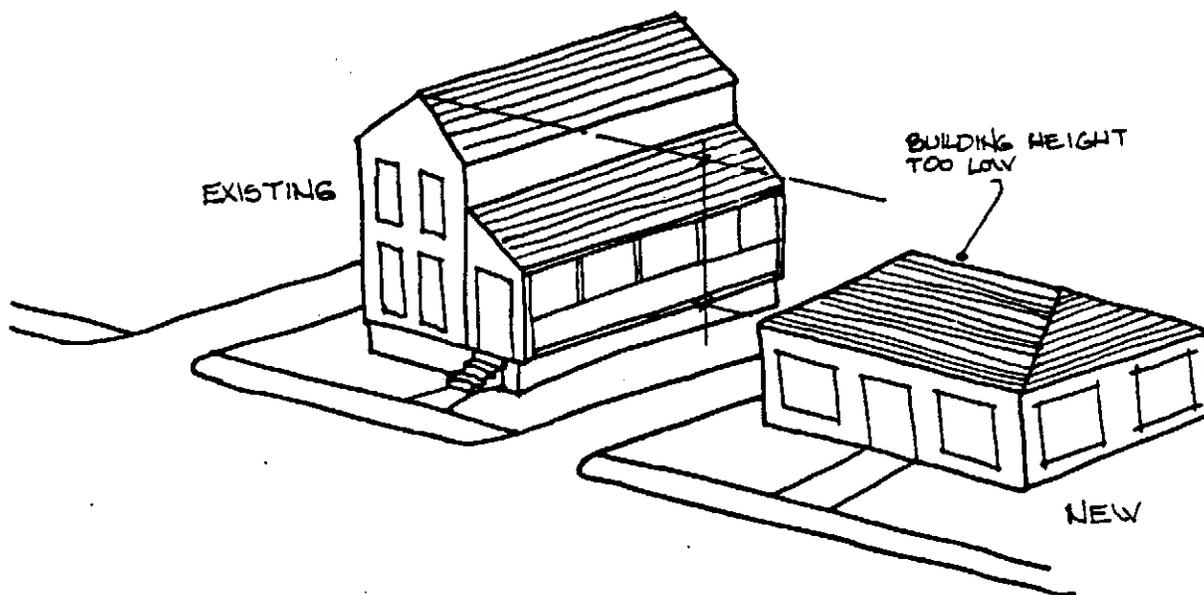
HEIGHT

3. Cornice line - Almost all the residential buildings in St. Mary's have a horizontal cornice across the main facade of the building. This line establishes the top of the building visually, and is therefore important to the overall scale. In order to assure the proper scale of a building in relation to those surrounding it, the height of the cornice line on the new building should be consistent with adjacent buildings.

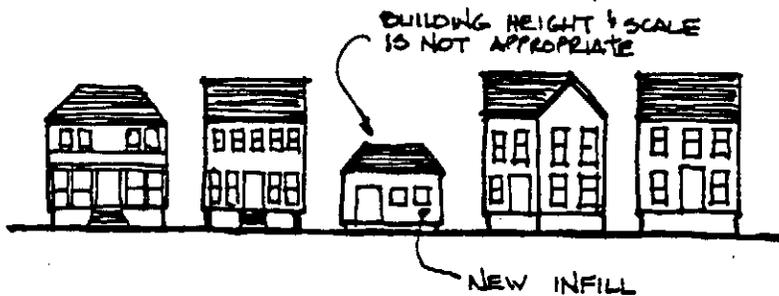
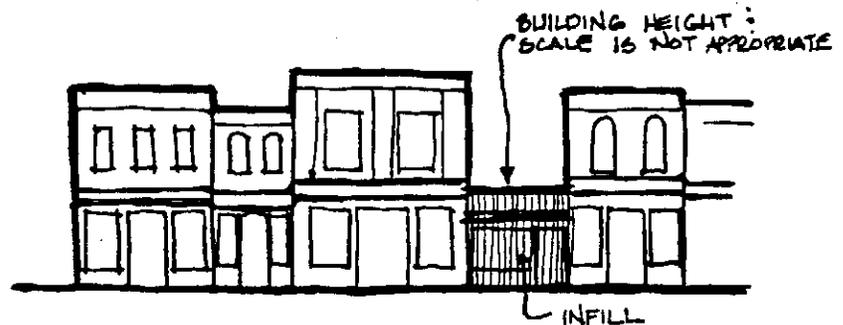
RHYTHM

Most of the buildings in St. Mary's are from one to two and a half stories tall. This would put their height from 15 to 35 feet. The St. Mary's zoning ordinance sets the maximum height for buildings in the historic district. In the residential area (R-1), the maximum height is 35 feet. In the commercial area (C-1), the height limit is 45 feet. Both of these limits should be respected within their designated districts, however, new structures should not vary more than 10% from the height of adjacent structures. For obvious reasons, it would be out of place to erect a two and a half story house in the middle of row of single story cottages.

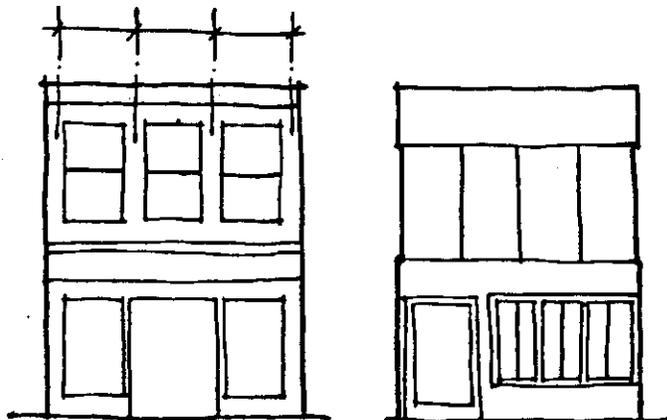
3. Solid to void relationship - There is also a definite pattern or balance between the areas of solid wall and windows and doors. In most early historic buildings there is a very well defined rhythm that is carefully maintained.

THIS

NOT THIS

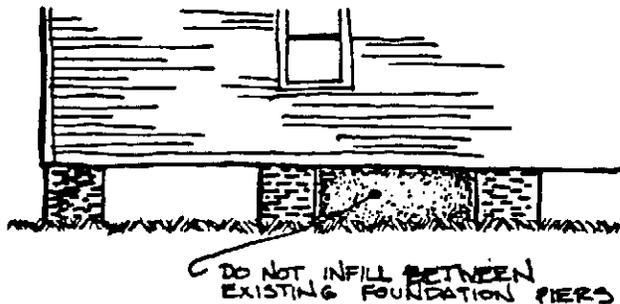
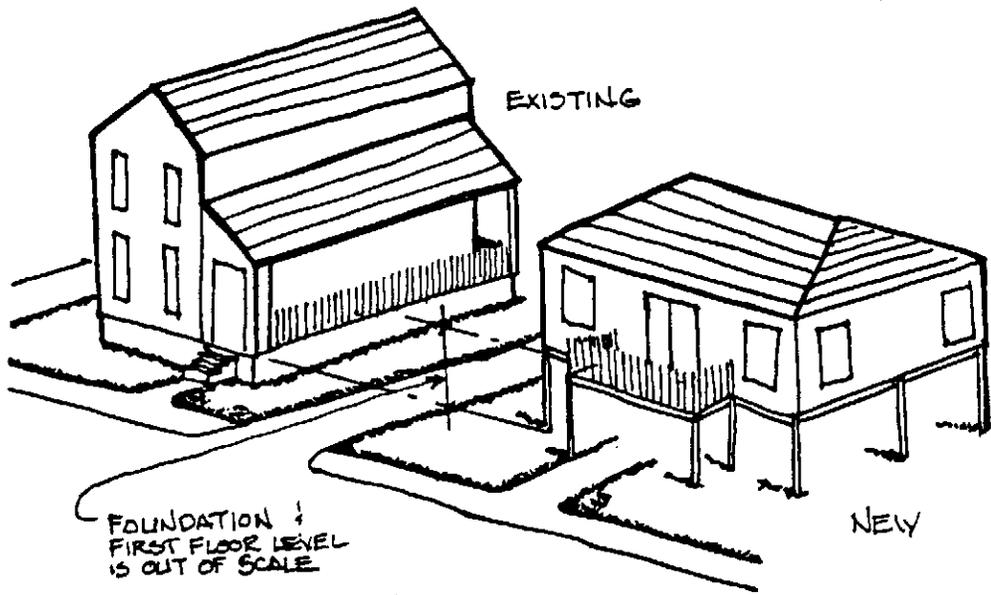
Foundations in the historic district range from modern structures on slab to historic buildings on raised brick foundations of as much as 6 feet in height. It is interesting to note that the oldest historic structures display the raised foundation as a protective measure against periodic flooding as well as to catch summer breezes. These brick foundations are frequently stucco over brick, scored to resemble stone, and painted.

Foundations of existing historic structures should not be altered. Brick piers should be retained, preferably in an unpainted state. In the case where a building is on brick piers as opposed to a solid, continuous foundation, this pier arrangement should be retained. Infill between the piers with modern brick work is not acceptable since it alters the original intended appearance of the foundation.

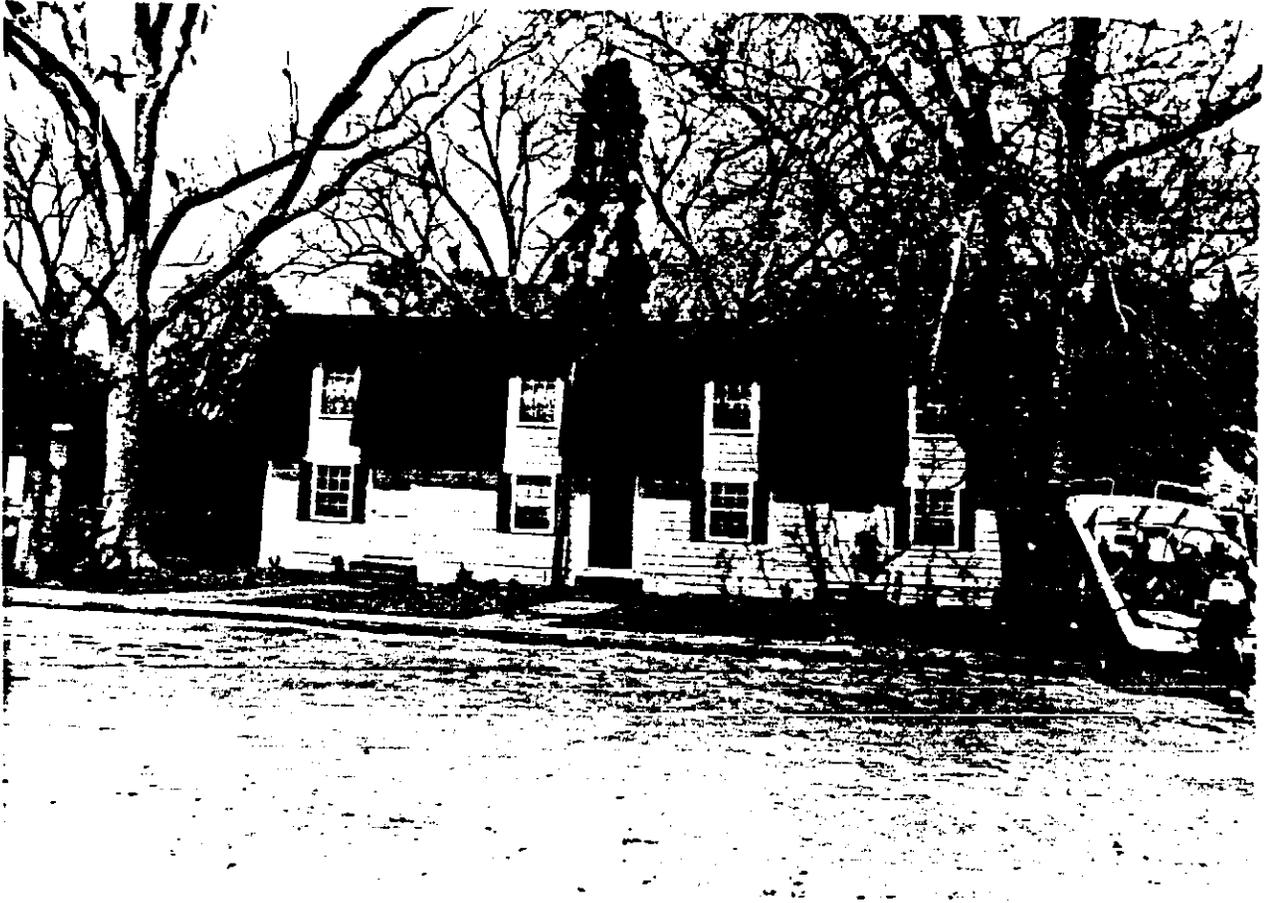
Most of the residential buildings in St. Mary's have gabled or hipped roofs of tin, asphalt shingle, or wooden shake shingle. The roof pitch varies from 3/12 to 12/12. Roof color varies from silver, red, or green tin to light grey or dark gray asphalt shingles, and a weathered natural color for the shake shingles.

Throughout the historic district large, unbroken roof areas should be avoided. Intrusive modern conveniences such as solar

panels, skylights, ventilation wind turbines and antennas should be hidden from public view.

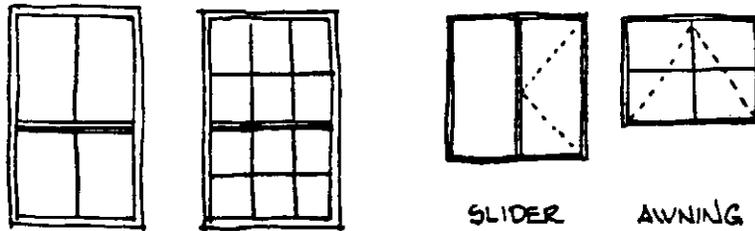
Fenestration is the arrangement of windows and doors on a building. In St. Mary's a variety of different window forms exist, but they are generally vertical rather than horizontal in emphasis, and they have multiple panes of glass as opposed to large single sheets. Windows are typically double-hung and the style of the window reflects the architectural style of the building. (See section on architectural styles)

DOUBLE HUNG

SLIDER AWNING

THIS

NOT THIS

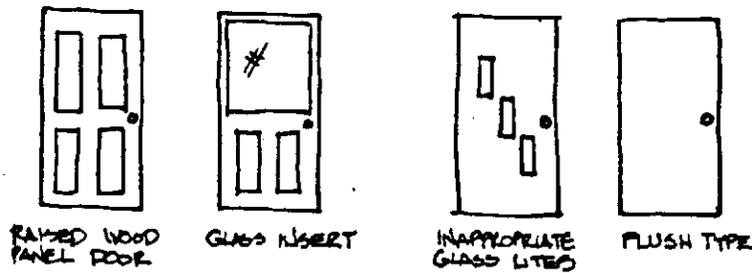
Doors in St. Mary's also are varied, again closely tied to the individual architectural style. Styles range from solid panelled doors to those with glass inserts. Door surrounds include sidelights, transom lights, and fan lights according to the individual architectural style. In some cases, doors are partially obscured from view by entrance porches.

RAISED WOOD PANEL DOOR

GLASS INSERT
