ST. MARY'S HISTORIC DISTRICT

GUIDELINES STUDY

JUNE 30, 1986

GALYON AND ASSOCIATES / PDM
POST OFFICE BOX 1645
CHARLESTON, SOUTH CAROLINA 29402

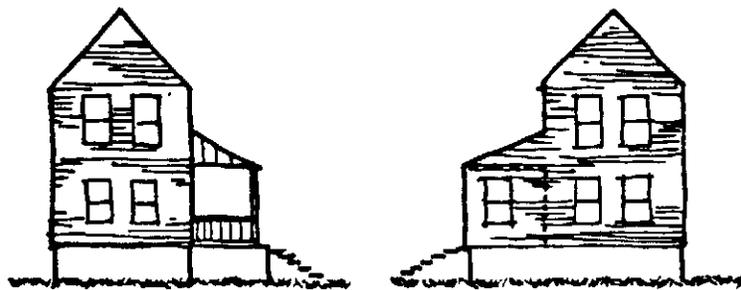
DO NOT ENCLOSE PORCH

3. Porch details should be made to match the building. Replacement parts should be as close to the original as possible.

5. Porches should be painted with colors sympathetic to those of the house. In many cases, the body and detail can be painted white with a dark floor and steps.

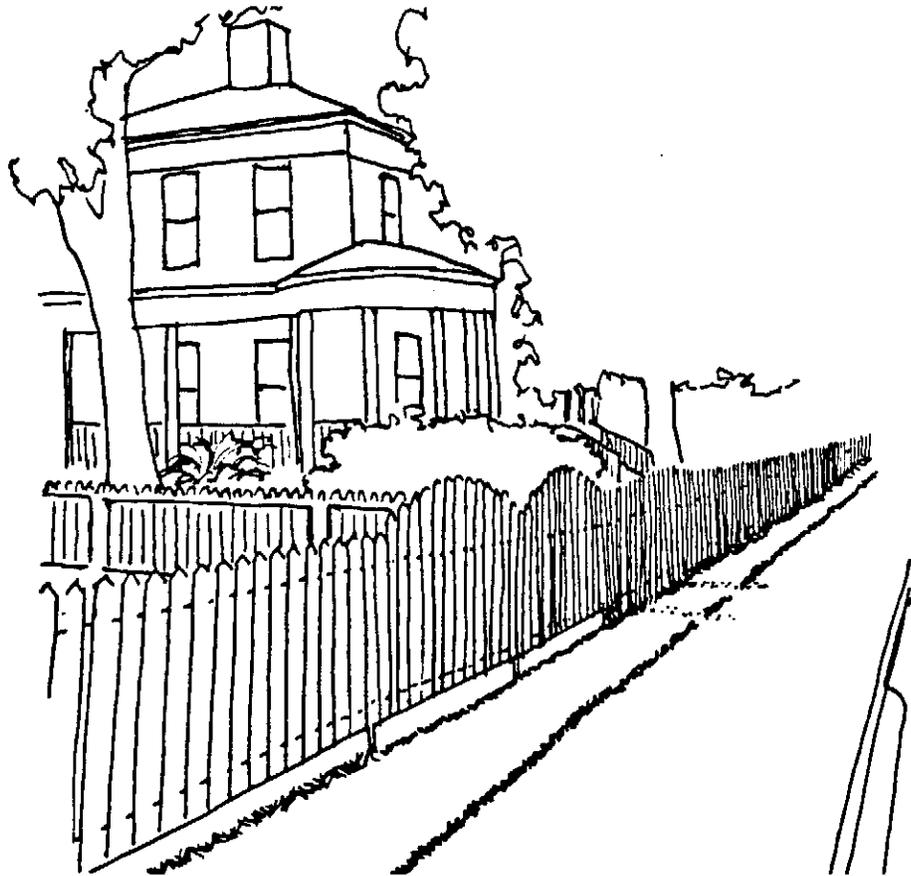
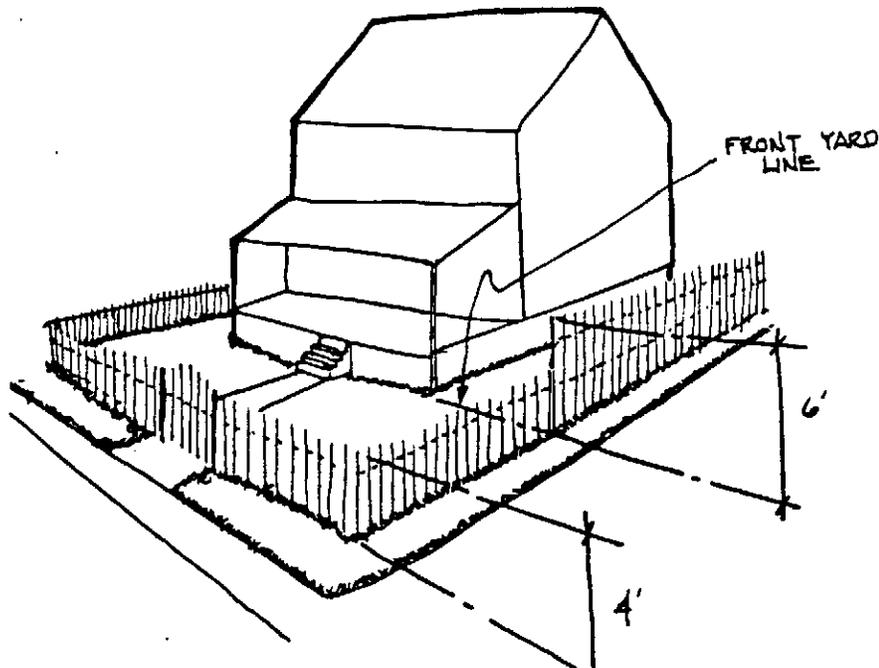
With the exception of one or two low concrete block walls, such as at the Bachlott Porter House, and modern chain link fences in multiple locations, picket fences are the rule. Since the use of picket fences around early Georgia buildings is widely acknowledged, particularly in rural and small town settings, this element should be retained throughout the historic district.

As a general rule, fences should be allowed on all property lines, but should not obstruct views of the building. For this reason fence heights should not exceed four feet in the front of the building and six feet in the side and rear.

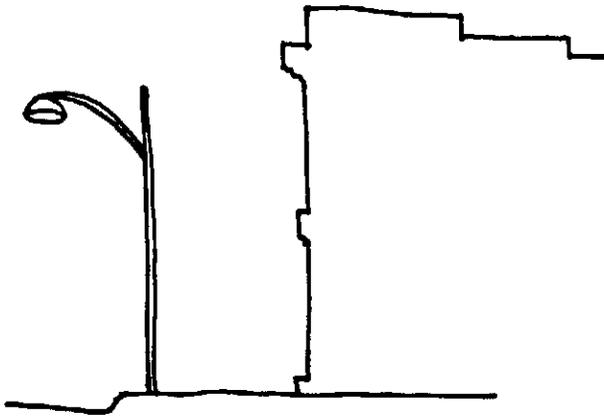
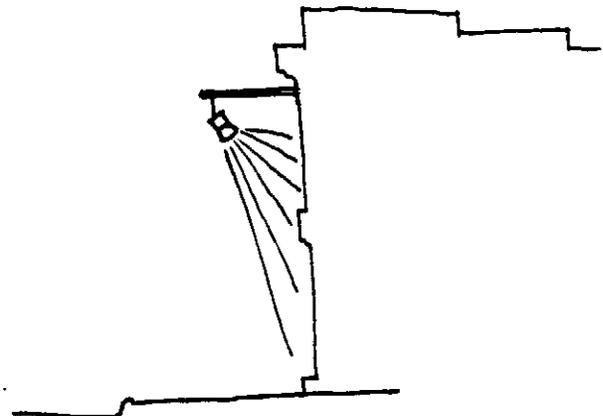
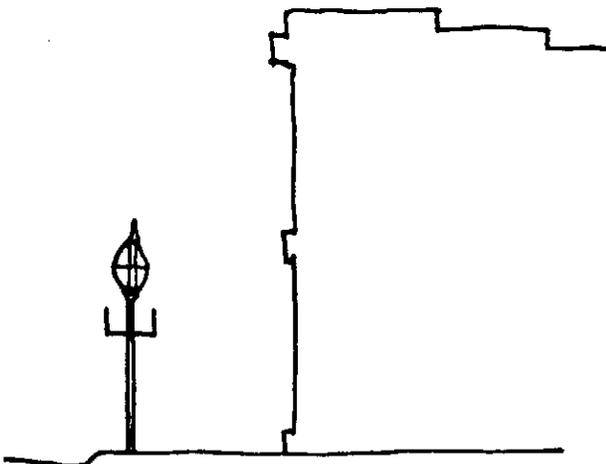
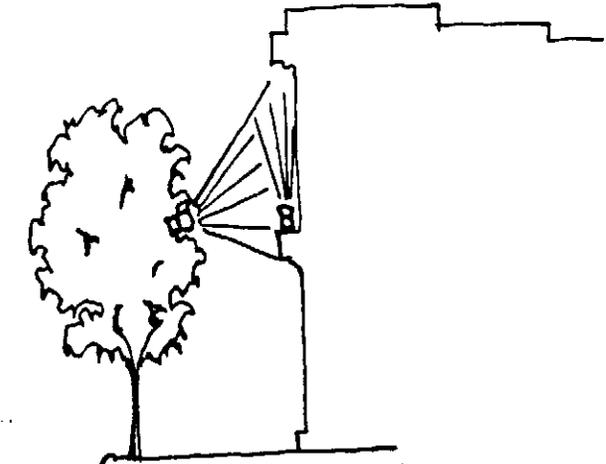
lighting of wall surfaces from detached fixtures should be discouraged, while lighting for landscaping should be subtle and hidden from view.

NOT THIS

THIS

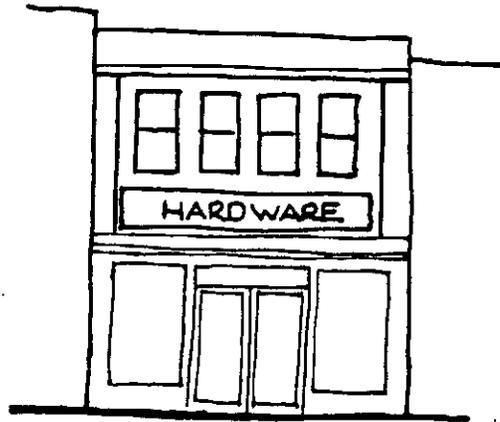
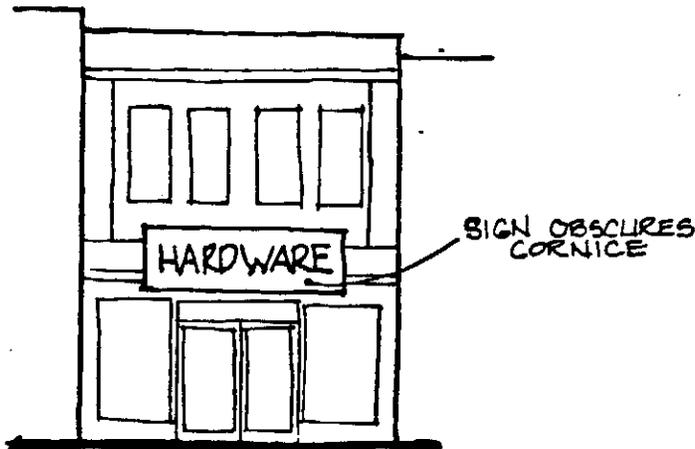
Exterior signs are generally uncommon in St. Mary's primarily due to the residential character of most of the district. The St. Mary's zoning ordinance has a strong sign provision with specific reference to the Historic District. From a general viewpoint, this section (907) is satisfactory. The solitary exception is the section allowing roof signs in the commercial part of the Historic District. Roof signs should be discouraged throughout the historic district.

THIS

NOT THIS

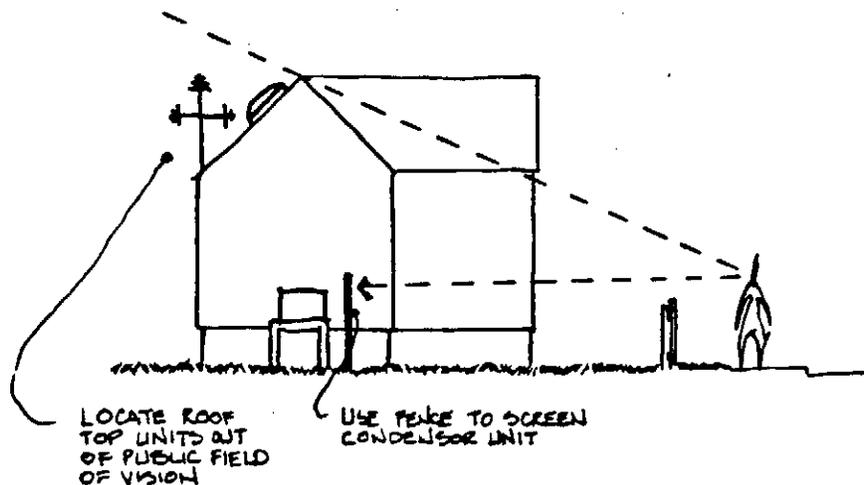
2. No air conditioning equipment should be allowed in a front yard area. Side and rear yard installation is acceptable provided the actual equipment is screened from view with ornamental fencing or plant screening. Landscaping should be the preferred screen although fencing is acceptable provided it is compatible with the building.
